Safe use of bed rails

MHRA has produced the Device Bulletin DB 2006(06) *Safe use of bed rails*. Please report problems with assistive technology products online, via the MHRA website www.mhra.gov.uk or e-mail: aic@mhra.gsi.gov.uk

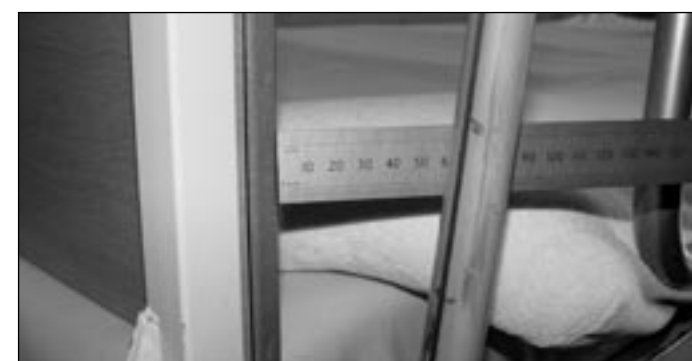
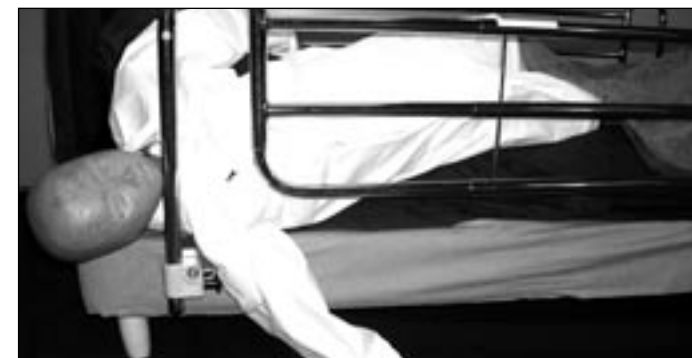
'Third party' bed rails, as photographed below, are not model specific and fit a wide range of beds. These are involved in most adverse incidents reported to us

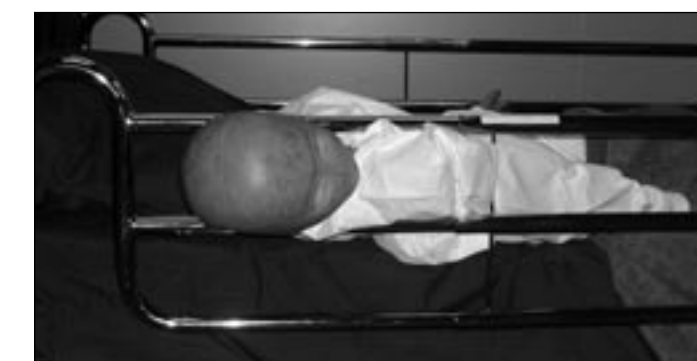
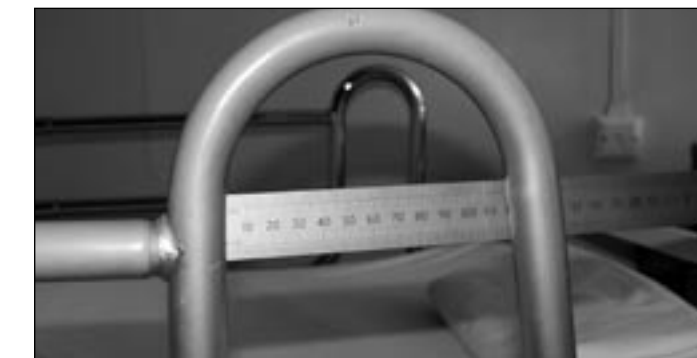
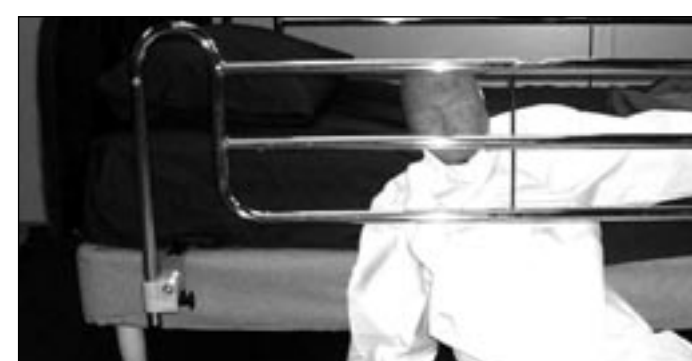
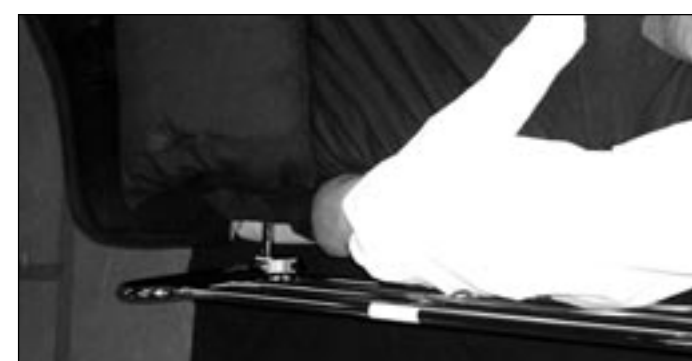
Design safety

For use with adults:

Bed rails should be fitted so that the gap between their end and the headboard is less than 60mm or greater than 250mm.

All gaps between the rail bars must be 120mm or less.

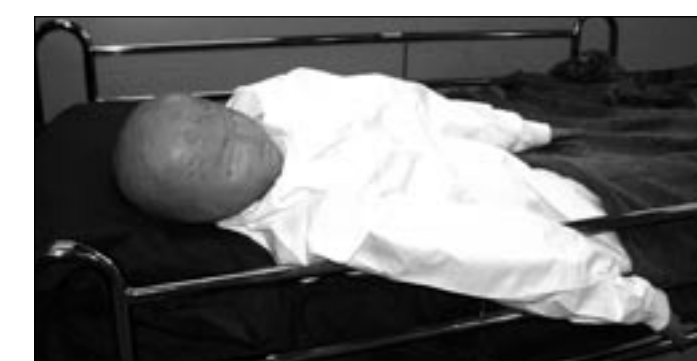
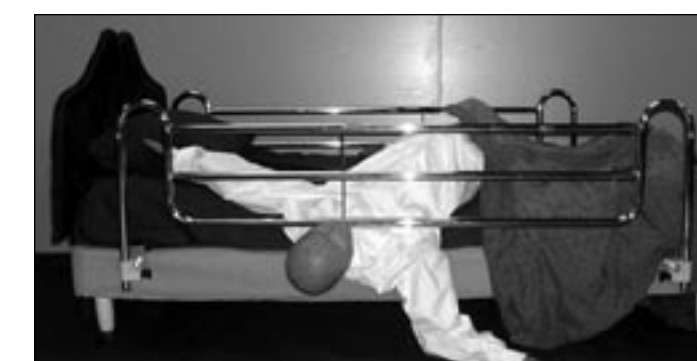
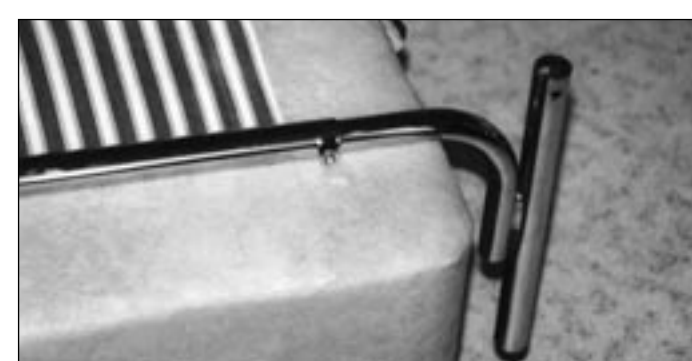
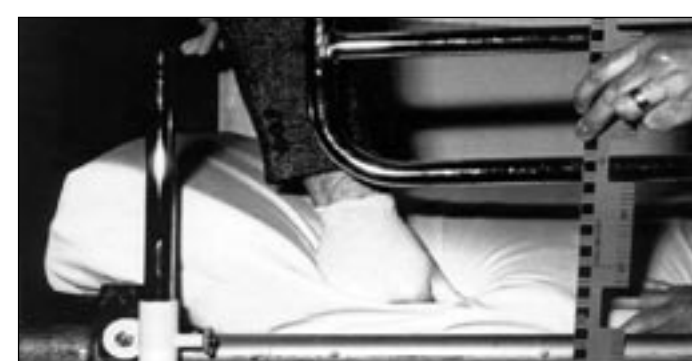
Hazardous positions

Most of the deaths caused by bed rails could have been avoided if thorough risk assessments of the bed occupant and the bed rail had been carried out.

MHRA investigations have also shown that many serious and fatal incidents with bed rails have been caused by a *lack of maintenance*.

Bed rails must be *inspected* on a regular basis to ensure they are in good condition.

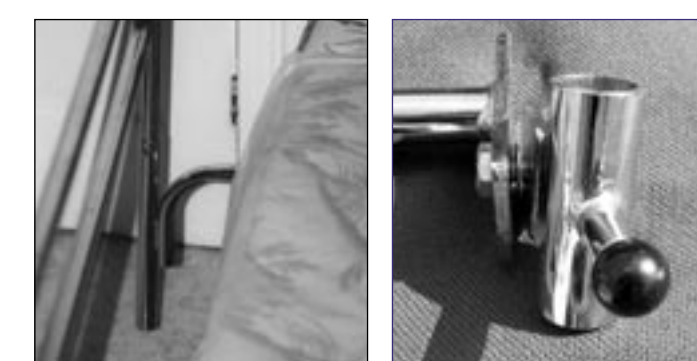
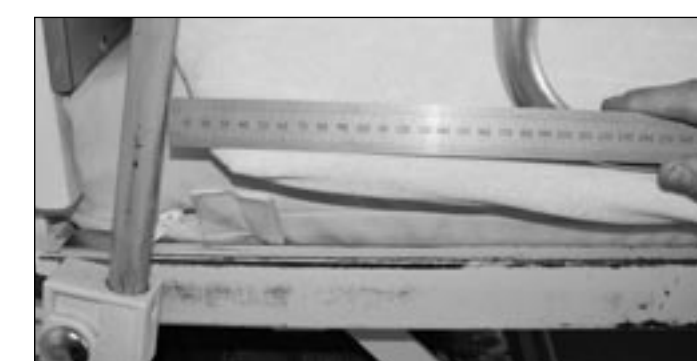
Things to avoid

- Gaps that could cause head, neck or chest entrapment between the end of the bed rail and the headboard or footboard.
- Using bed rails designed for divan beds on wooden or metal bedsteads.
- Using insecure fittings that let the bed rail move away from the side of the bed.
- Using bed rails that have not been maintained regularly.
- Bed rails with parts missing.
